# HARTFORD AND NORWICH BUS STOP STUDY 2016

## ADVANCE TRANSIT

Prepared for Advance Transit by the Two Rivers-Ottawaquechee Regional Commission  
with Public Transit Planning funds from the Vermont Agency of Transportation

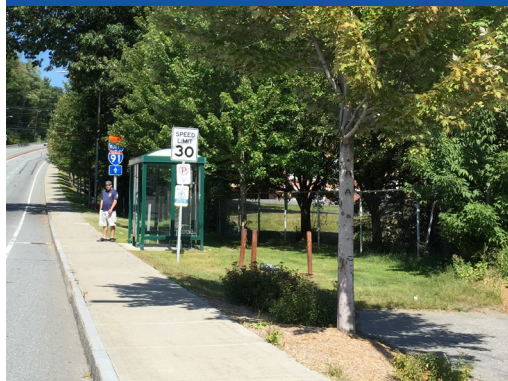
FIGURE 10: BUS STOP AT CO-OP ILLUSTRATING CURBSIDE STOP

**Curbside:** Buses pull up to the curb. This is the most common configuration for a bus stop for a number of reasons; mostly it does not require any changes to the street environment. A curbside stop may be in the travel lane or on a shoulder in the road.

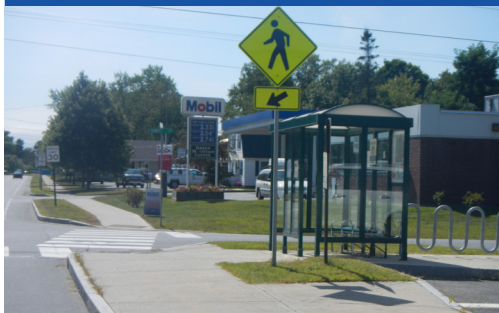
FIGURE 11: BUS STOP AT TAFTS FLATS ILLUSTRATING CROSSWALKS IN VICINITY

- **Crosswalks:** Are there crosswalks nearby? Like sidewalks, crosswalks are an important indicator of how well the bus stop is served by the pedestrian network. Crossings nearby are important because transit patrons often arrive on one side of the street and depart on the other.

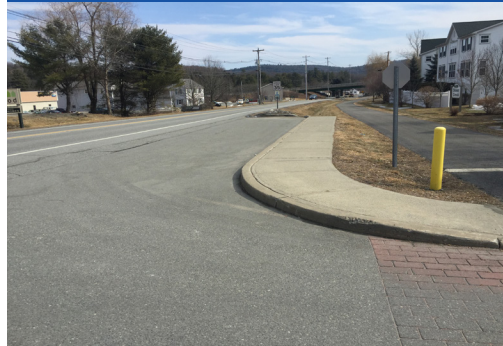
**FIGURE 18: STONEY CREEK BUS STOP**

Some bus stops are designed to allow the bus to pull out of traffic in areas where there is not parallel parking on the street. These are found in some locations on the Advance Transit system such as Stoney Creek.

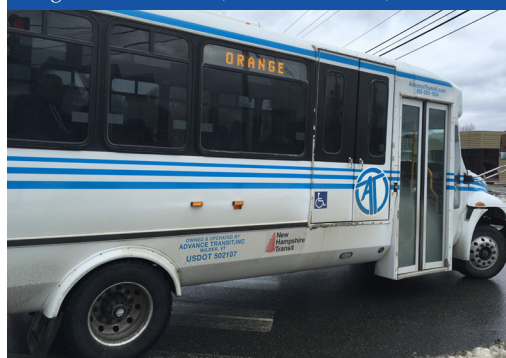
FIGURE 21: ADVANCE TRANSIT'S INTERNATIONAL BUS FLEET

The basic dimensional characteristics of the transit vehicles form a foundation for the bus stop designs in terms of dedicating adequate curb space to the bus stop. Advance Transit's fleet that serves the Green/Orange/Brown fixed route service are smaller buses called Internationals (Figure 21). These buses are 34-feet long and 96-inches (8 ft.) wide and have one door for boarding and alighting.

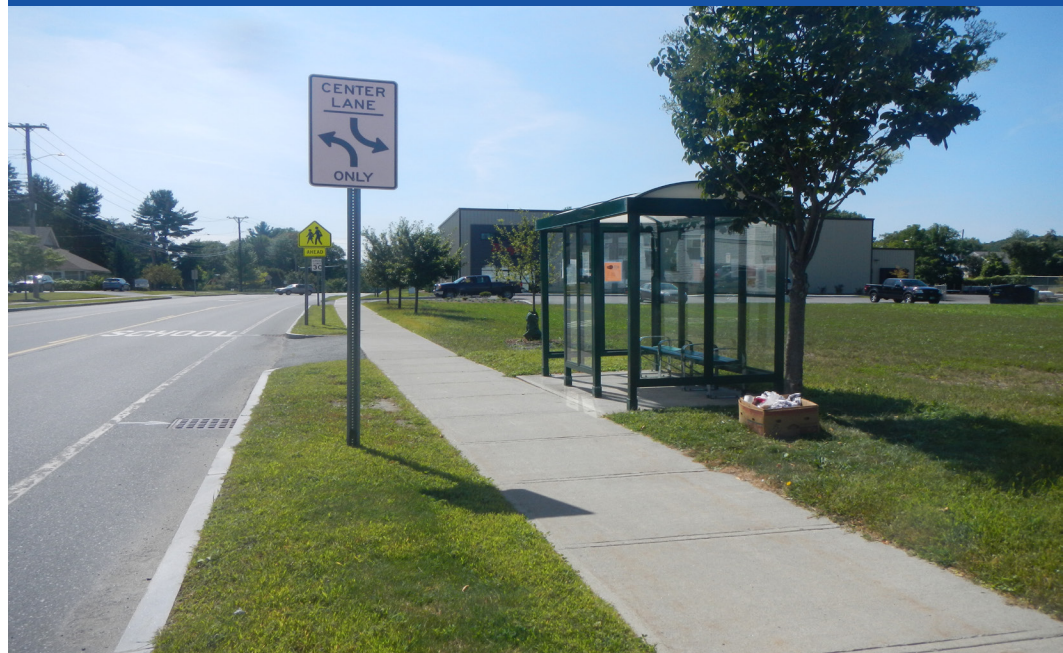
FIGURE 22: SIDEWALK ALONG SANDERS BUS STOP

Sidewalks and the bus stop landing pad area a core element of every bus stop. In general, bus stops should be well-connected into the surrounding neighborhood by sidewalks that enable passengers a safe and attractive travel route to and from the stop as illustrated in Figure 22. Safe and attractive sidewalk connections to transit stops help encourage transit use.

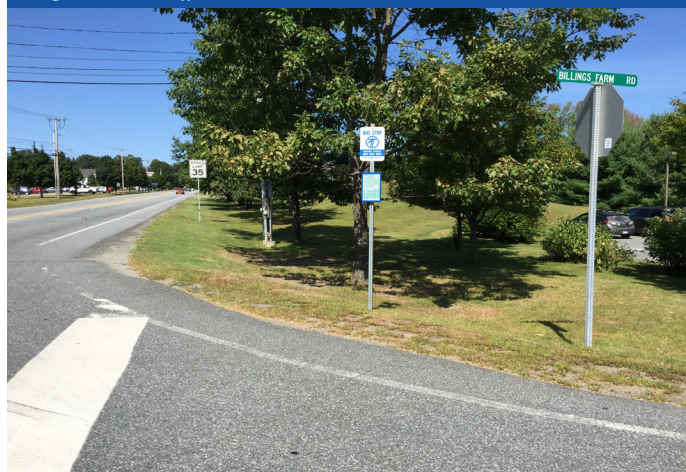
FIGURE 48: EXISTING BILLINGS FARM RD BUS STOP

- > Bus stop located at an intersection, challenging for buses to pull over out of travel lane but also in front of turning lane
- > Need shelter
- > State Right of Way boundary is unclear
- > Underground utilities may impact shelter location

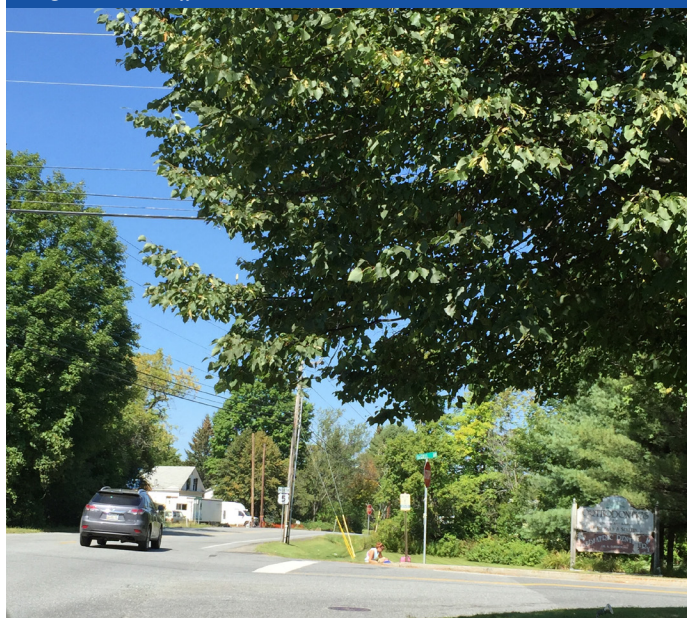
FIGURE 49: EXISTING OLCOTT DRIVE BUS STOP

The Olcott Drive bus stop on the Green Route heading northbound to Hanover, NH faces similarities to Billings Farm Rd. The bus stop provides access to Olcott Industrial Park averaging 101 boardings a month. The bus currently pulls out of US5 traffic and blocks Olcott Drive to board and alight passengers. A shelter has been identified for installation to improve passenger experience but will require additional engineering to determine State right-of-way and shelter location. Figure 49 illustrates passengers waiting for the bus by sitting on the grass which is not feasible during the winter season.

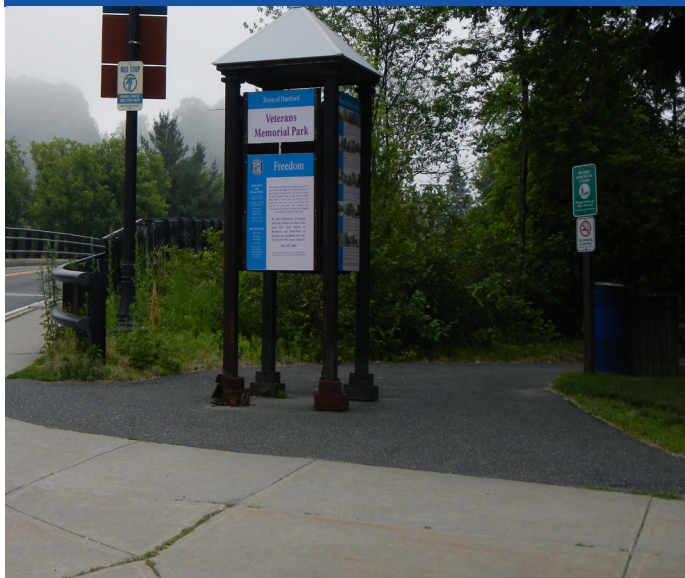
The Veteran's Park stop on the Orange Route averages 136 boardings a month. The stop only has a bus stop sign currently but the unique feature of this stop is that it is next to the Veteran's Memorial Park which has a historic gateway kiosk. The kiosk itself is in poor condition and will require replacement in the future. Advance Transit has recognized a potential partnership with the Town of Hartford envisioning a new bus stop with a bus shelter designed to incorporate the Veteran's Memorial Park historic information and become the new gateway feature.

- > Bus stop located at an intersection, challenging for buses to pull over out of travel lane but also blocking Railroad Row
- > A historic kiosk is aging and will need replacement

- > Need design/engineering for a new shelter design to incorporate a historic kiosk to replace existing historic marker
- > Work with Town of Hartford to improve bus stop shelter design

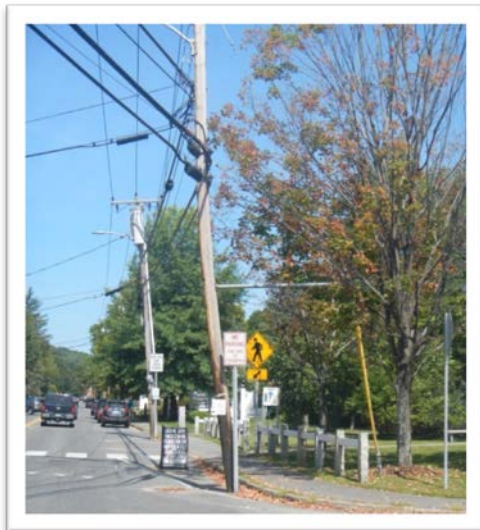
### Tracy Hall

Route(s):	Brown	Buses per Day:	15	Traffic Volume:	2,500
Headway:	30 minutes	Avg. Monthly Boardings:	10	Traffic Speed:	25
Street:	Main Street	Accessibility:	Yes	Amenities:	
Sign:	Yes	Sidewalks:	Yes	Notes:	
Shelter:	No	Crosswalks:	Yes		
Bus Stop:	Curbside: Travel Lane	Bike Racks:	No		Crosswalk in winter time is icy.

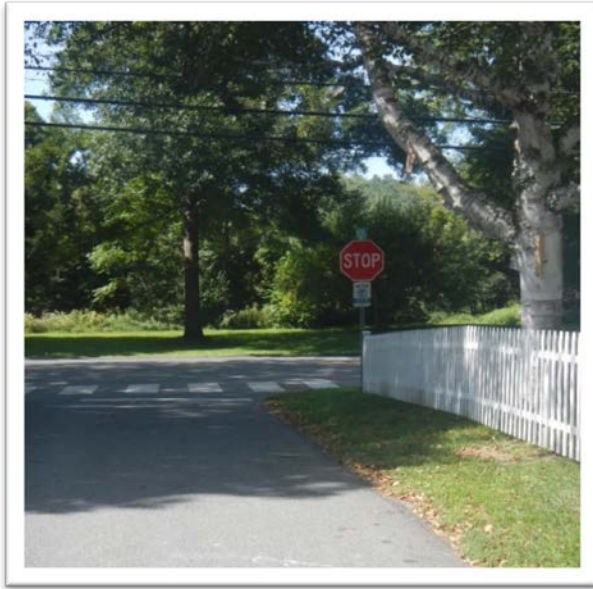
### Hazen + Cliff

Route(s):	Brown	Buses per Day:	12	Traffic Volume:	250
Headway:	30 minutes	Avg. Monthly Boardings:	0	Traffic Speed:	25
Street:	Hazen Street	Accessibility:	Yes	Amenities:	
Sign:	Yes	Sidewalks:	No	Notes:	
Shelter:	No	Crosswalks:	No		
Bus Stop:	Curbside: Travel Lane	Bike Racks:	No	Recommend removal of stop

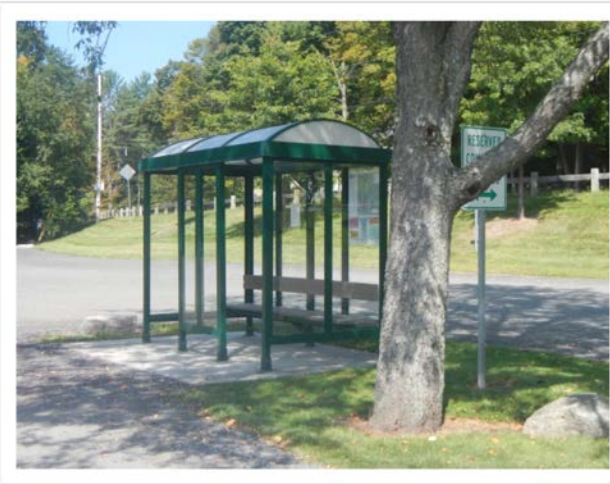
### Park + Ride, Turnpike Road

Route(s):	Brown	Buses per Day:	7	Traffic Volume:	500
Headway:	30 minutes	Avg. Monthly Boardings:	45	Traffic Speed:	25
Street:	Turnpike Road	Accessibility:	Yes	Amenities:	
Sign:	Yes	Sidewalks:	No	Notes:	
Shelter:	No	Crosswalks:	Yes	Should reverse shelter orientation, turnaround challenge if lot is full	
Bus Stop:	Curbside: Travel Lane	Bike Racks:	No

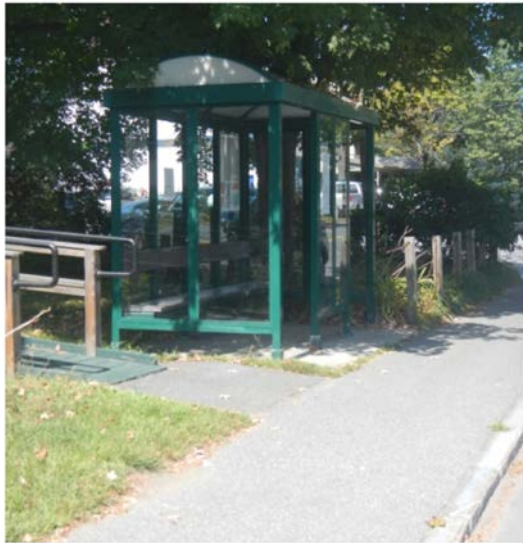
### Dan + Whits

Route(s):	Brown	Buses per Day:	18	Traffic Volume:	2,500
Headway:	30 minutes	Avg. Monthly Boardings:	448	Traffic Speed:	25
Street:	Main Street	Accessibility:	Yes	Amenities:	
Sign:	Yes	Sidewalks:	Yes	Notes:	
Shelter:	Yes	Crosswalks:	Yes		
Bus Stop:	Curbside: Travel Lane	Bike Racks:	No		
Drivers unwilling to yield to buses back into traffic

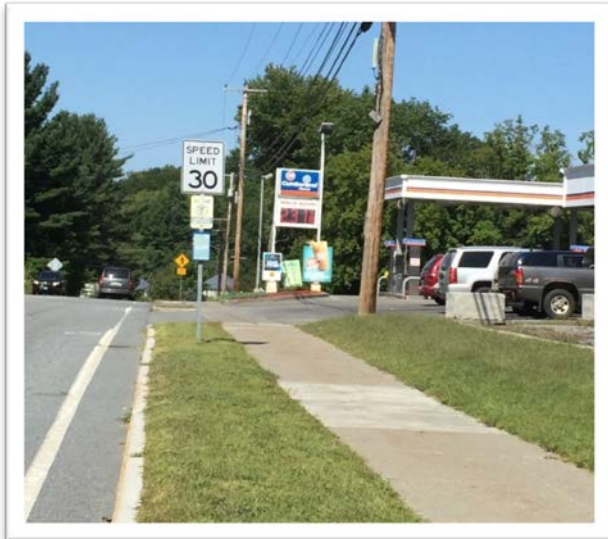
### Knights Funeral

Route(s):	Green	Buses per Day:	26	Traffic Volume:	6,500
Headway:	30 minutes	Avg. Monthly Boardings:	52	Traffic Speed:	30
Street:	US5	Accessibility:	No	Amenities:	
Sign:	Yes	Sidewalks:	Yes	Notes:	
Shelter:	No	Crosswalks:	No		
Bus Stop:	Curbside: Travel Lane	Bike Racks:	No

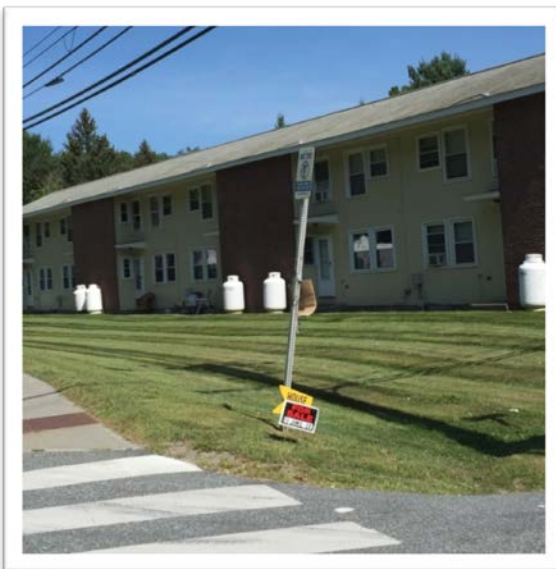
### Cumberland Farms

Route(s):	Green	Buses per Day:	26	Traffic Volume:	6,500
Headway:	30 minutes	Avg. Monthly Boardings:	27	Traffic Speed:	30
Street:	US5	Accessibility:	No	Amenities:	
Sign:	Yes	Sidewalks:	Yes	Notes:	
Shelter:	No	Crosswalks:	No		
Bus Stop:	Curbside: Travel Lane	Bike Racks:	No

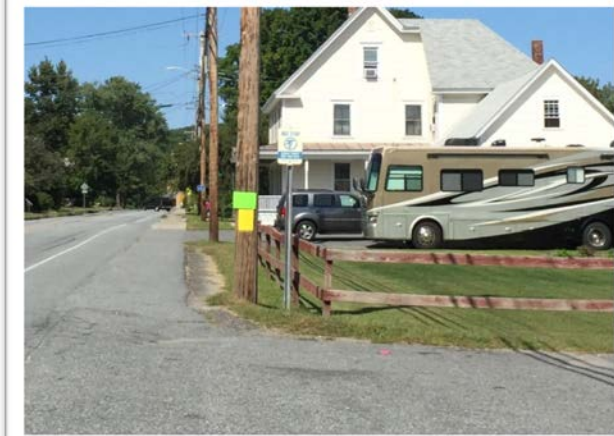
### A Street

Route(s):	Green	Buses per Day:	26	Traffic Volume:	6,500
Headway:	30 minutes	Avg. Monthly Boardings:	42	Traffic Speed:	30
Street:	US5	Accessibility:	Yes	Amenities:	
Sign:	Yes	Sidewalks:	Yes	Notes:	
Shelter:	No	Crosswalks:	No		
Bus Stop:	Curbside: Travel Lane	Bike Racks:	No

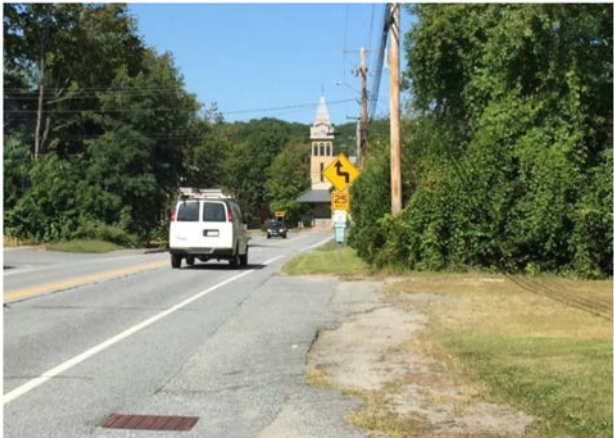
### Depot Street

Route(s):	Green	Buses per Day:	26	Traffic Volume:	6,500
Headway:	30 minutes	Avg. Monthly Boardings:	88	Traffic Speed:	30
Street:	US5	Accessibility:	Yes	Amenities:	
Sign:	Yes	Sidewalks:	No	Notes:	
Shelter:	No	Crosswalks:	No		
Bus Stop:	Curbside: Travel Lane	Bike Racks:	No

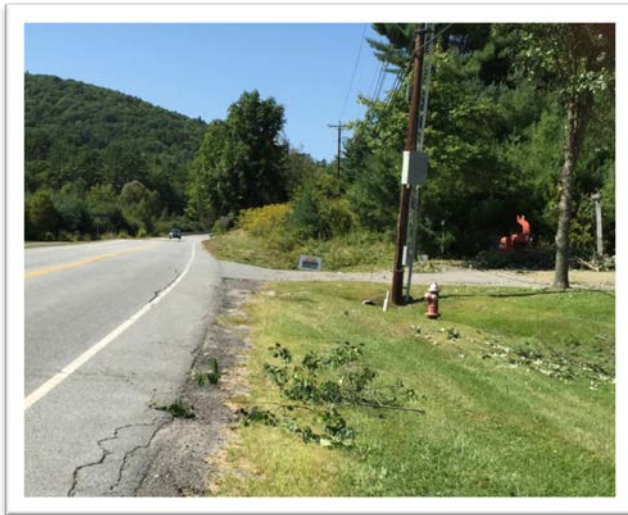
### Datamann, Opposite

Route(s):	Green	Buses per Day:	26	Traffic Volume:	4,800
Headway:	30 minutes	Avg. Monthly Boardings:	219	Traffic Speed:	30
Street:	US5	Accessibility:	No	Amenities:	
Sign:	Yes	Sidewalks:	No	Notes:	Needs shelter
Shelter:	No	Crosswalks:	No		
Bus Stop:	Curbside: Travel Lane	Bike Racks:	No

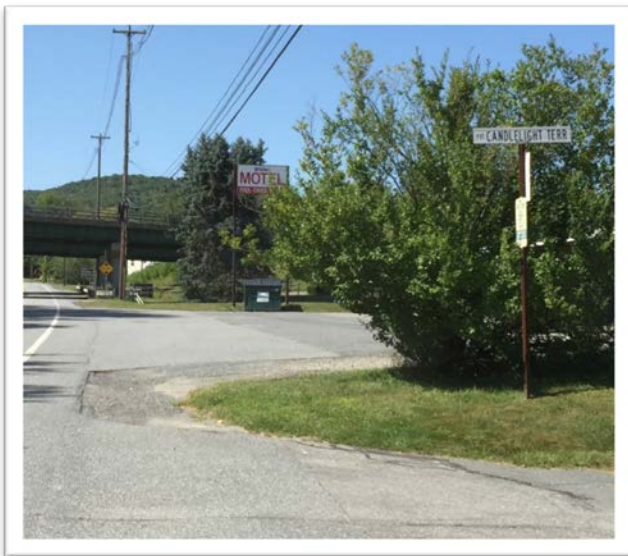
### FedEx

Route(s):	Green	Buses per Day:	26	Traffic Volume:	4,000
Headway:	30 minutes	Avg. Monthly Boardings:	54	Traffic Speed:	30
Street:	US5	Accessibility:	No	Amenities:	
Sign:	Yes	Sidewalks:	No	Notes:	
Shelter:	No	Crosswalks:	No		
Bus Stop:	Curbside: Travel Lane	Bike Racks:	No

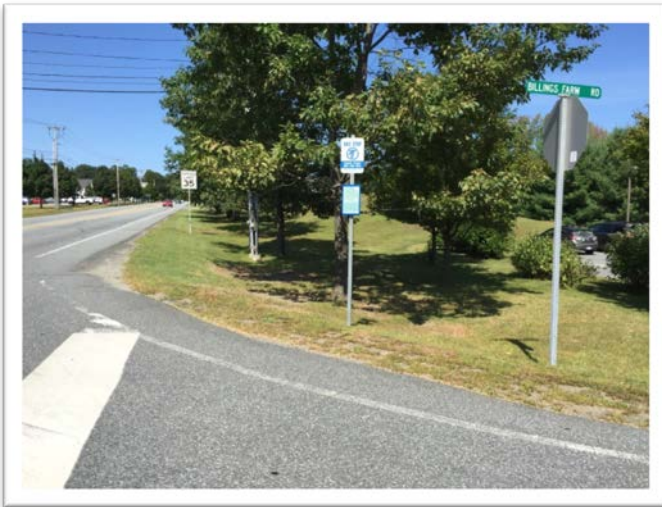
### Wilder Motel

Route(s):	Green	Buses per Day:	26	Traffic Volume:	3,400
Headway:	30 minutes	Avg. Monthly Boardings:	39	Traffic Speed:	30
Street:	US5	Accessibility:	Yes	Amenities:	
Sign:	Yes	Sidewalks:	No	Notes:	
Shelter:	No	Crosswalks:	No		
Bus Stop:	Curbside: Travel Lane	Bike Racks:	No

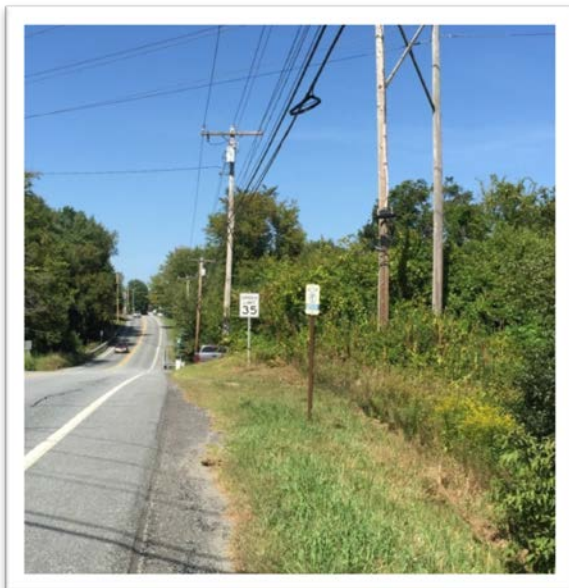
### Billings Farm Road

Route(s):	Green	Buses per Day:	26	Traffic Volume:	4,900
Headway:	30 minutes	Avg. Monthly Boardings:	131	Traffic Speed:	30
Street:	US5	Accessibility:	No	Amenities:	Notes: Needs shelter
Sign:	Yes	Sidewalks:	No		
Shelter:	No	Crosswalks:	No		
Bus Stop:	Curbside: Travel Lane	Bike Racks:	No

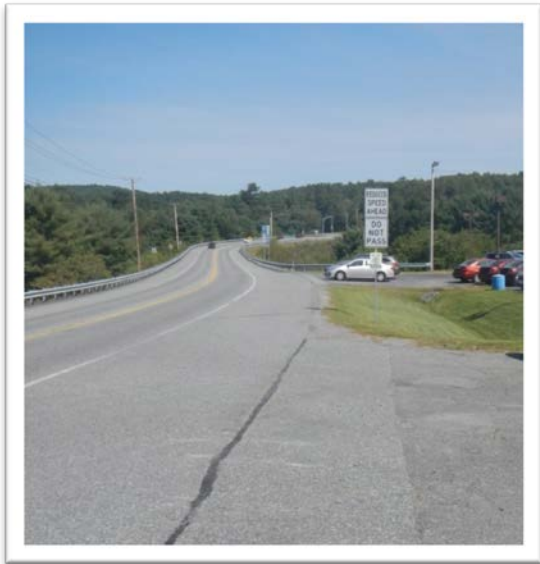
### King Arthur Flour

Route(s):	Green	Buses per Day:	26	Traffic Volume:	4,100
Headway:	30 minutes	Avg. Monthly Boardings:	27	Traffic Speed:	30
Street:	US5	Accessibility:	Yes	Amenities:	
Sign:	Yes	Sidewalks:	No	Notes:	
Shelter:	Yes	Crosswalks:	No		
Bus Stop:	Curbside: Shoulder pull-off	Bike Racks:	Yes

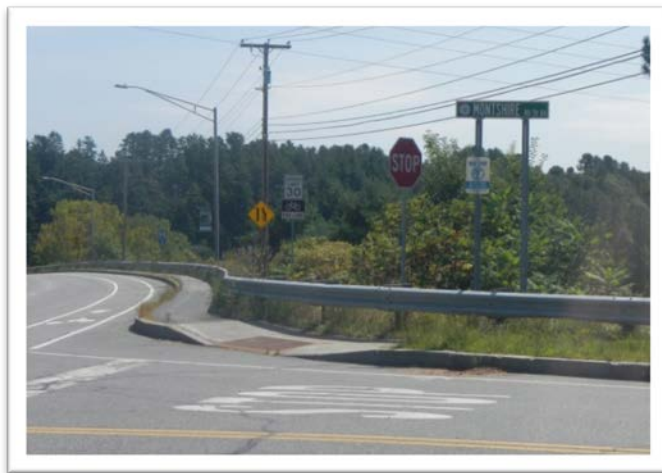
### Car Store

Route(s):	Green	Buses per Day:	26	Traffic Volume:	4,100
Headway:	30 minutes	Avg. Monthly Boardings:	9	Traffic Speed:	30
Street:	US5	Accessibility:	No	Amenities:	
Sign:	Yes	Sidewalks:	No	Notes:	
Shelter:	No	Crosswalks:	No		
Bus Stop:	Curbside: Shoulder pull-off	Bike Racks:	No

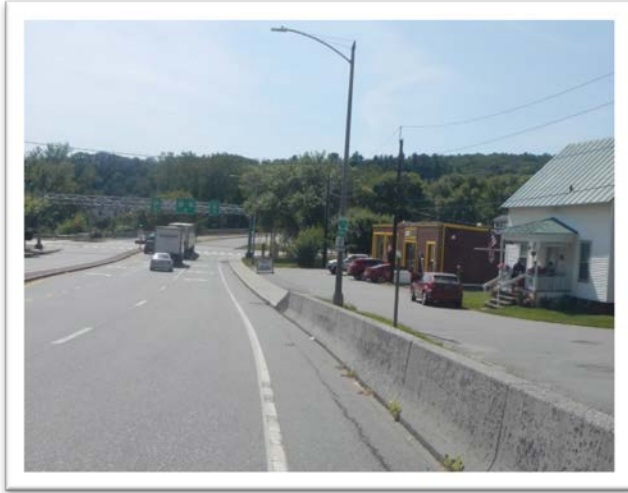
### Saunders Avenue

Route(s):	Green	Buses per Day:	26	Traffic Volume:	6,500
Headway:	30 minutes	Avg. Monthly Boardings:	568	Traffic Speed:	30
Street:	US5	Accessibility:	No	Amenities:	
Sign:	Yes	Sidewalks:	Yes	Notes:	
Shelter:	Yes	Crosswalks:	No	Although there is a shelter and sidewalk, the grass buffer prevents wheelchair accessibility to the bus.	
Bus Stop:	Curbside: Travel Lane	Bike Racks:	No

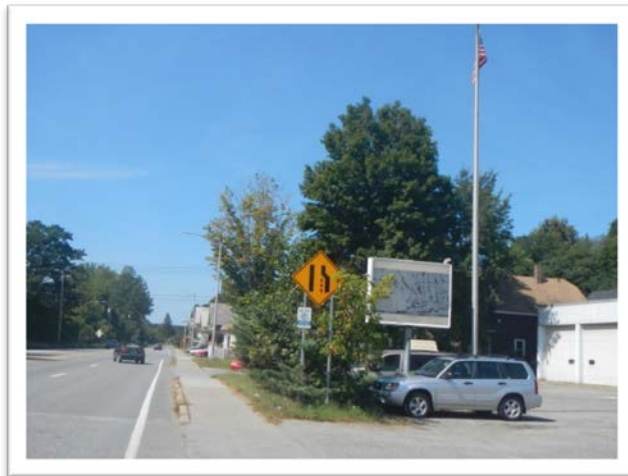
### Cota + Cota

Route(s):	Green	Buses per Day:	26	Traffic Volume:	6,500
Headway:	30 minutes	Avg. Monthly Boardings:	31	Traffic Speed:	30
Street:	US5	Accessibility:	No	Amenities:	
Sign:	Yes	Sidewalks:	No	Notes:	
Shelter:	No	Crosswalks:	No	Unsafe to stop, especially in winter, should remove stop permanently	
Bus Stop:	Curbside: Travel Lane	Bike Racks:	No

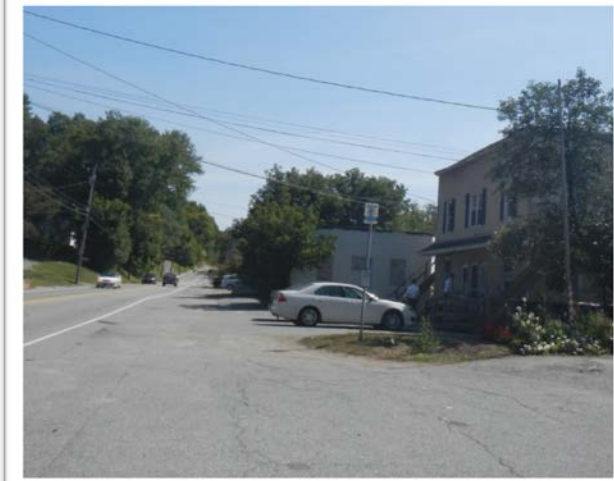
### VA Cutoff Bridge

Route(s):	Green	Buses per Day:	26	Traffic Volume:	4,400
Headway:	30 minutes	Avg. Monthly Boardings:	455	Traffic Speed:	30
Street:	VT14	Accessibility:	Yes	Amenities:	
Sign:	Yes	Sidewalks:	No	Notes:	
Shelter:	No	Crosswalks:	No		
Bus Stop:	Curbside: Travel Lane	Bike Racks:	No	Needs ADA and winter maintenance

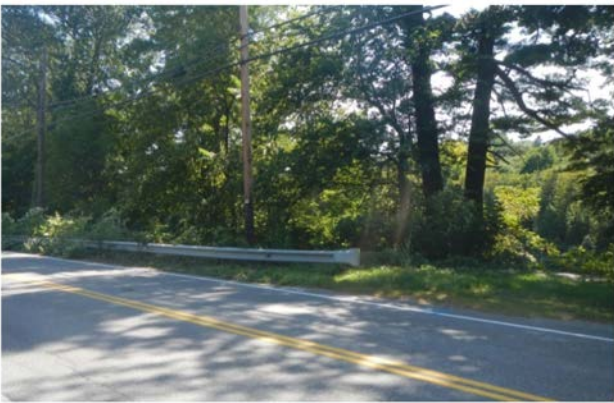
### Post Office

Route(s): Green  
 Headway: 30 minutes  
 Street: VT14  
 Sign: Yes  
 Shelter: No  
 Bus Stop: Curbside: Travel Lane

Stop sign disappears in winter in snow pile

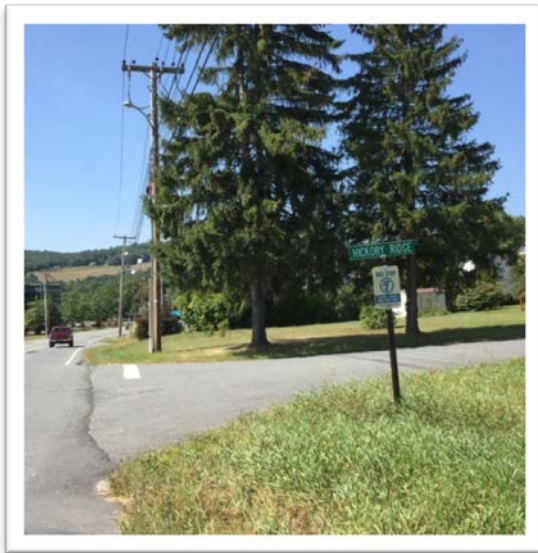
### Trailer Park + Sykes Mtn Ave

Route(s):	Orange	Buses per Day:	12	Traffic Volume:	5,400
Headway:	60 minutes	Avg. Monthly Boardings:	112	Traffic Speed:	30
Street:	Sykes Mtn Ave	Accessibility:	No	Amenities:	
Sign:	Yes	Sidewalks:	No	Notes:	
Shelter:	No	Crosswalks:	No		
Bus Stop:	Curbside: Travel Lane	Bike Racks:	No

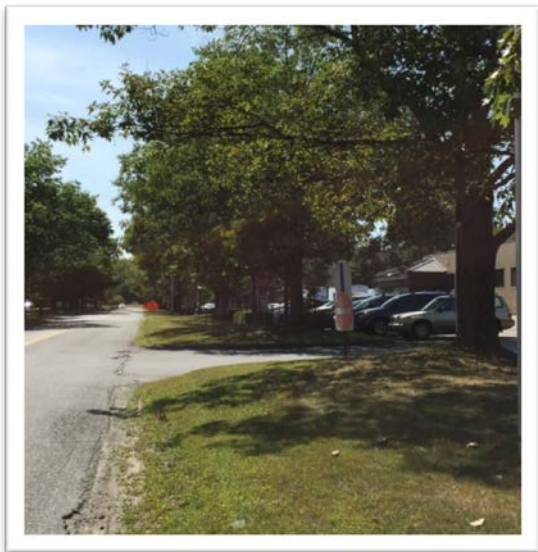
### Hickory Ridge

Route(s):	Orange	Buses per Day:	12	Traffic Volume:	5,400
Headway:	60 minutes	Avg. Monthly Boardings:	45	Traffic Speed:	30
Street:	Sykes Mtn Ave	Accessibility:	No	Amenities:	
Sign:	Yes	Sidewalks:	No	Notes:	Needs shelter
Shelter:	No	Crosswalks:	No		
Bus Stop:	Curbside: Travel Lane	Bike Racks:	No

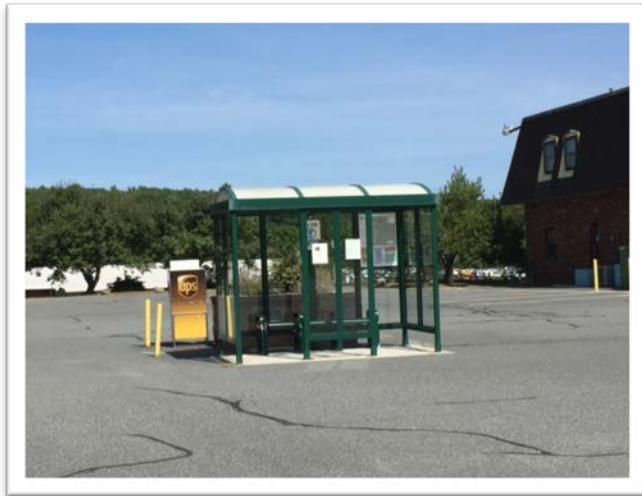
### Post Office, Drop off only

Route(s):	Orange	Buses per Day:	12	Traffic Volume:	5,400
Headway:	60 minutes	Avg. Monthly Boardings:	0	Traffic Speed:	30
Street:	Holiday Dr	Accessibility:	No	Amenities:	
Sign:	No	Sidewalks:	No	Notes:	
Shelter:	No	Crosswalks:	No		
Bus Stop:	Curbside: Travel Lane	Bike Racks:	No

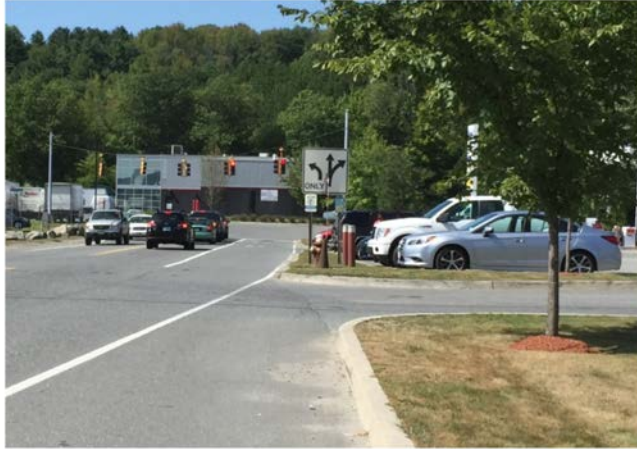
### Mascoma Savings Bank

Route(s):	Orange	Buses per Day:	12	Traffic Volume:	5,400
Headway:	60 minutes	Avg. Monthly Boardings:	7	Traffic Speed:	30
Street:	Holiday Dr	Accessibility:	No	Amenities:	
Sign:	No	Sidewalks:	No	Notes:	
Shelter:	No	Crosswalks:	No		
Bus Stop:	Curbside: Travel Lane	Bike Racks:	No

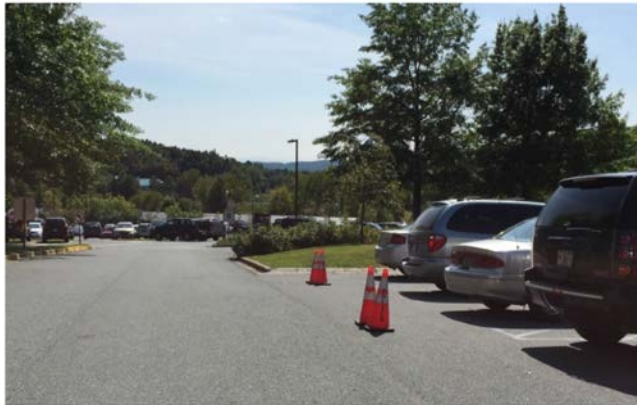
### Greyhound

Route(s):	Orange	Buses per Day:	12	Traffic Volume:	10,000
Headway:	60 minutes	Avg. Monthly Boardings:	172	Traffic Speed:	30
Street:	Sykes Mtn Ave	Accessibility:	Yes	Amenities:	
Sign:	No	Sidewalks:	No	Notes:	
Shelter:	No	Crosswalks:	No		
Bus Stop:	Curbside: Travel Lane	Bike Racks:	No

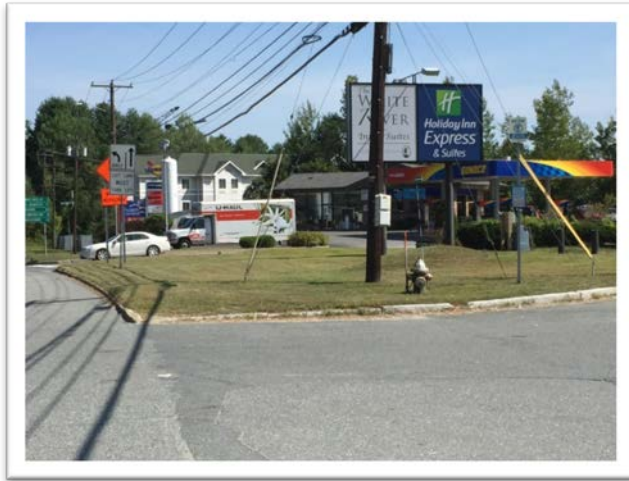
### VA Hospital Outpatient Entrance

Route(s):	Orange	Buses per Day:	12	Traffic Volume:	7,500
Headway:	60 minutes	Avg. Monthly Boardings:	334	Traffic Speed:	15
Street:	VA	Accessibility:	Yes	Amenities:	
Sign:	No	Sidewalks:	No	Notes:	
Shelter:	No	Crosswalks:	No		
Bus Stop:	Parking lot	Bike Racks:	No

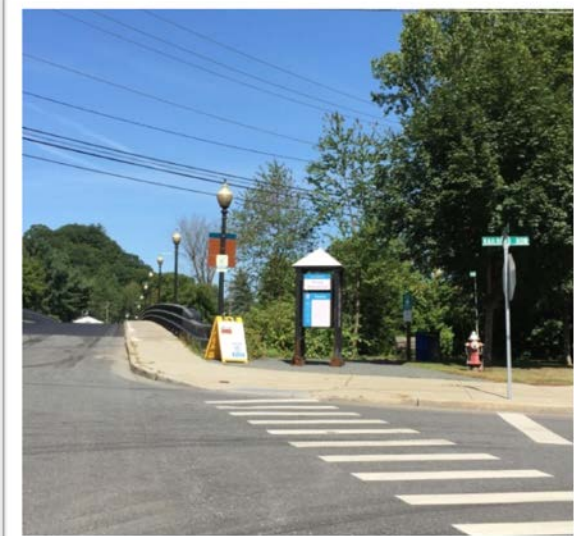
### Twin Rivers

Route(s):	Orange	Buses per Day:	12	Traffic Volume:	3,100
Headway:	60 minutes	Avg. Monthly Boardings:	39	Traffic Speed:	25
Street:	N Main St	Accessibility:	Yes	Amenities:	
Sign:	Yes	Sidewalks:	Yes	Notes:	
Shelter:	No	Crosswalks:	Yes		
Bus Stop:	Curbside: Travel Lane	Bike Racks:	No

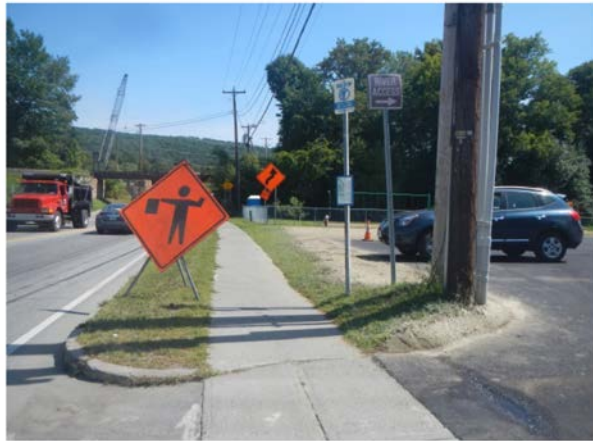
### Bridge Street

Route(s):	Orange	Buses per Day:	12	Traffic Volume:	3,800
Headway:	60 minutes	Avg. Monthly Boardings:	136	Traffic Speed:	25
Street:	Bridge Street	Accessibility:	Yes	Amenities:	Notes: Needs shelter
Sign:	Yes	Sidewalks:	Yes		
Shelter:	No	Crosswalks:	Yes		
Bus Stop:	Curbside: Travel Lane	Bike Racks:	No
